# Joulen Analysis of Reports into the Spanish Grid Blackout April 2025

By Daniel Parke and Jessica Fletcher

# Introduction

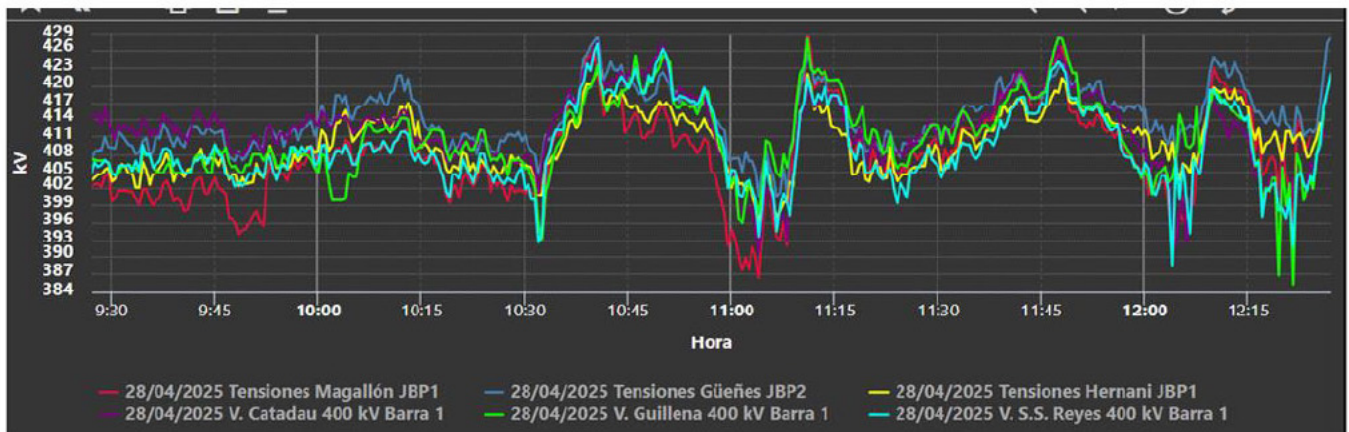
- Initially operating conditions were normal, with low demand and generation in line with historical norms for this time (07:15 - 07:20).
- As Solar PV generation increased, a larger variation of voltages was observed in the

Figure 2. Voltage in 400 kV transmission network from 09:30 to 12 30

- At 11:09 this resulted in two substations tripping as they exceeded their operating voltages, both located in the same regional area (Zaragoza).
- At 12:00 system conditions were still fully compliant and within operational procedures, with no indications of the building issue. However at 12:03 significant frequency oscillations (0.6Hz) were observed in the Spanish-French interconnector.
- This resulted in severe voltage fluctuations, reaching up to 30kV across most substations, with a maximum fluctuation of 410kV being observed (see graphs below).

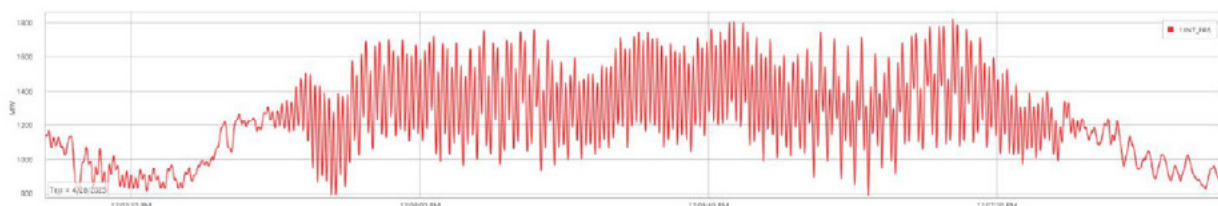
Figure 3. Exchange Spain-France between 12:02 to 12:08 (0.6 Hz oscillation)

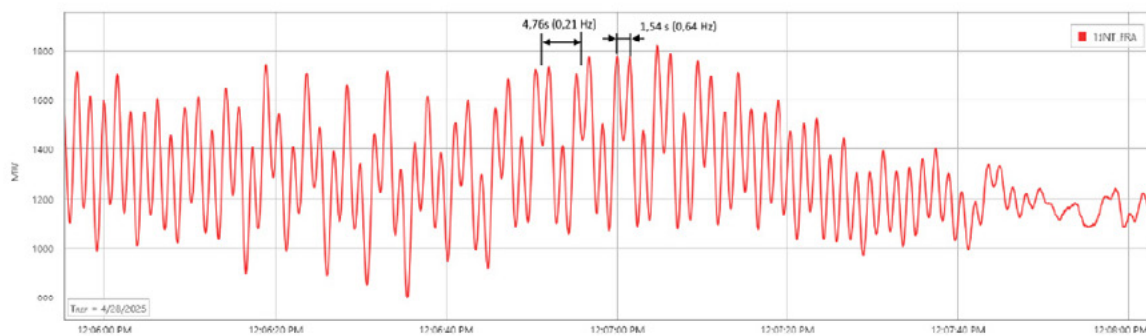
Figure 4. Exchange Spain-France between 12:06 to 12:08 (0.6 Hz oscillation)

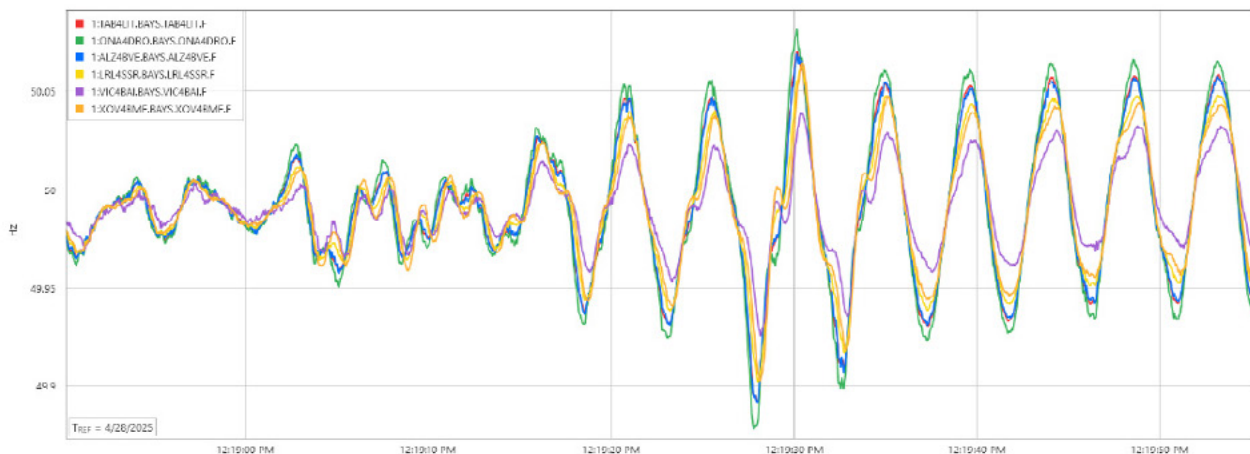
- At 12:19 further oscillations were observed with the same magnitude, although these were quickly dampened. PV Plant A generation had increased from 250MW - 350MW, however variations in reactive power elements were still detected (see graph below).

Figure 5. Initial moments of the 0.2 Hz oscillation where 0.6 Hz oscillation can also be observed

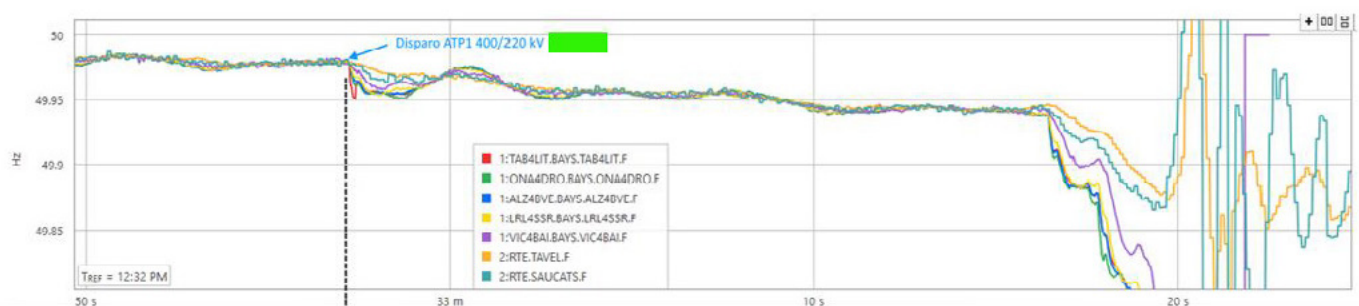
- At 12:32 another substation tripped, which was supplying 355MW whilst absorbing 165MVar. This led to a cascade effect due to the increased pressure on the network, which was already under extreme stress, with voltages rising after this again.

Figure 7. Evolution of the system before and after the trip in Granada
